**Southwest Research Institute (SwRI) Project
18.03562
"Evaluation of Tungsten Alloy Rods"
Final Report**

Kathryn Dannemann and James Walker

May 2000

IAT.R 0301

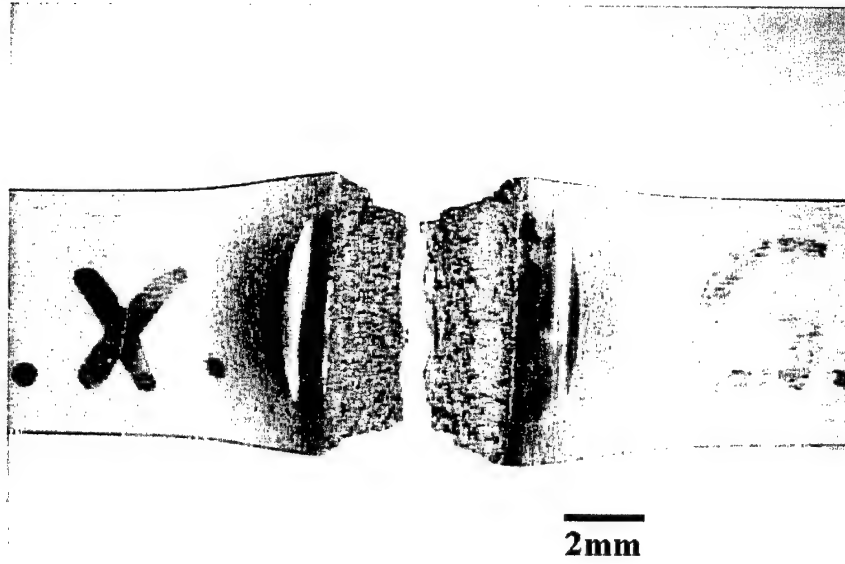
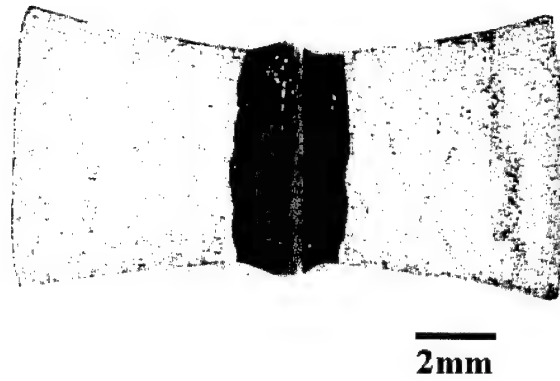
The cross sections of the fractured bend samples were trapezoidal, as shown in Figure 1 for sample A. Both tensile and compressive fracture modes were operative, though the samples ultimately failed in tension. The compression component is due to bending. Several tensile cracks were detected in the mounted cross-sections on the opposite side of the sample from the bend (i.e., tensile side). The cracks were most prevalent in the vicinity of the fracture surface, as shown in Figure 2a. The longest tensile cracks measured approximately 0.15 to 0.17 mm long.

Figure 1. Condition of Sample A following dynamic bend testing. The bottom photo illustrates the fracture cross-section.

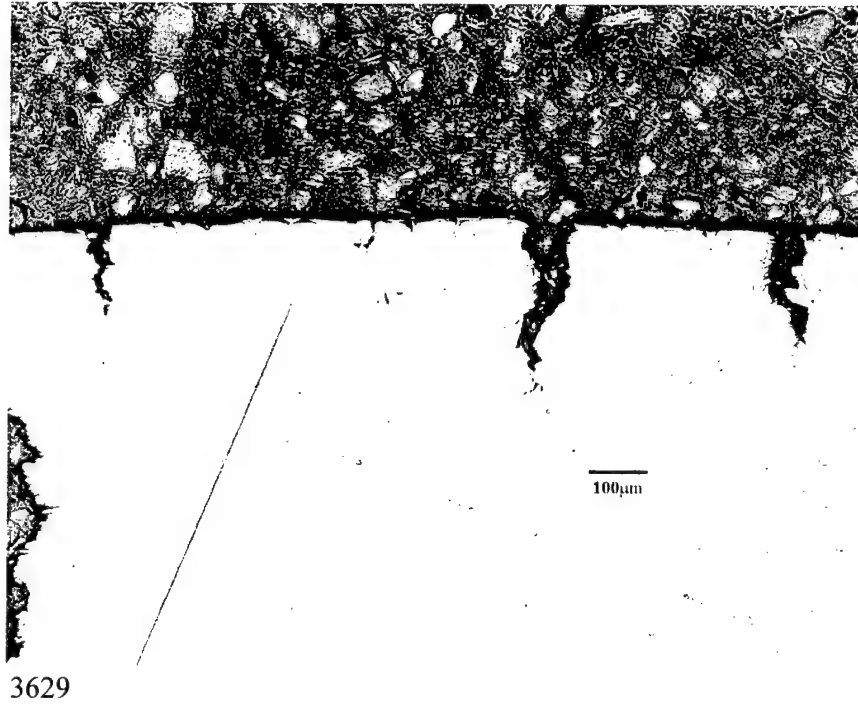
(a) Several tensile cracks in the vicinity of the fracture surface for Sample A

The cracks initiated at the tensile surface and progressed towards the compressive side of the sample in a direction approximately parallel to the fracture surface. Ultimate failure of the sample occurred in tension when the load capacity of the sample was exceeded due to competitive, crack growth processes from opposite sides of the sample diameter.

Figure 2. Tensile cracks on the tensile surface (side opposite the bend surface) of the dynamic bend test samples.

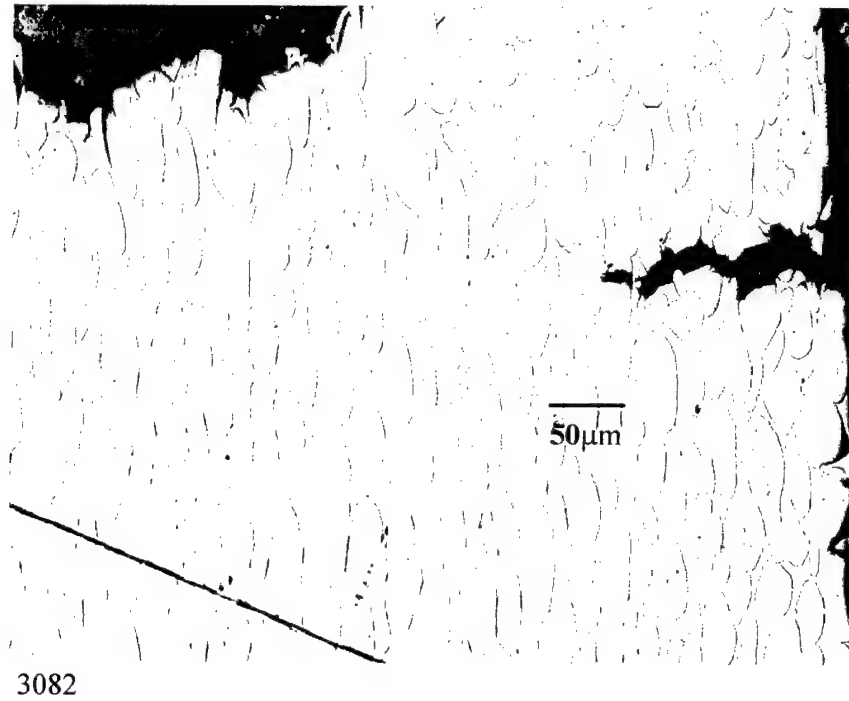
(b) Enlargement of leftmost crack in (a) for Sample A

Figure 2. Tensile cracks on the tensile surface (side opposite the bend surface) of the dynamic bend test samples (continued).

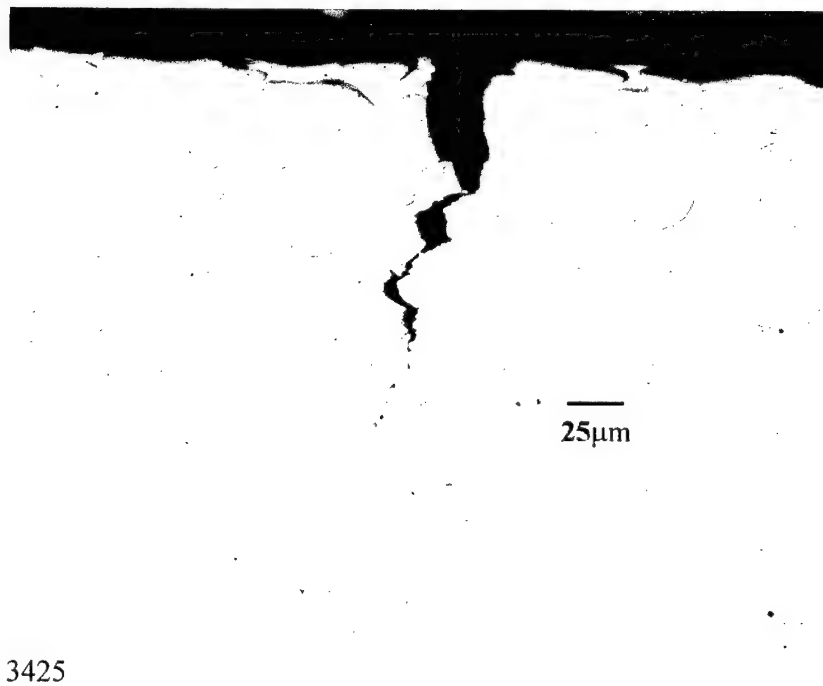
(c) Enlargement of tensile crack for Sample B showing particle fracture

Higher magnification microscopy of the mounted cross-sections revealed the tensile cracks progressed through some of the W particles, resulting in cleavage of the particles. Fracture of the W particles is evident in representative photos of the tensile cracks, illustrated in Figure 2. The cracks also progressed along W particle/matrix interfaces. Some W particle fractures were observed on the compressive side of the samples near the initial bend region. A limited number of isolated W particle fractures and W particle/matrix fractures were detected towards the center of the sample cross section. Some fractured W particles were observed along the fracture surface on both the tensile and compressive sides of the samples evaluated. Particle fractures were more prevalent on the tensile fracture surface. Some W particle-particle decohesion was detected for W particles just beneath the fracture surface. Depending on the microstructure, damage progressed from the debonded regions along adjacent particles or particle/matrix interfaces.

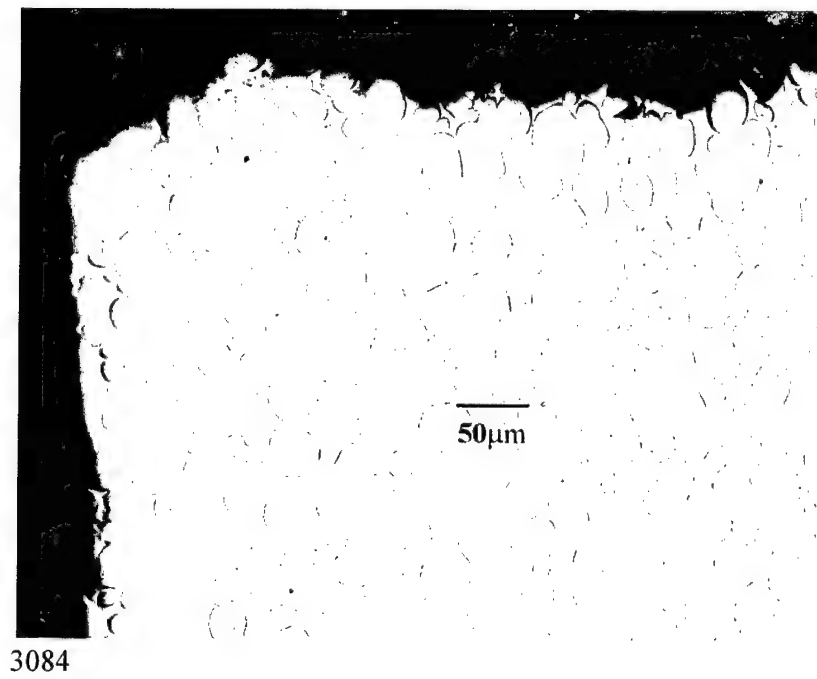
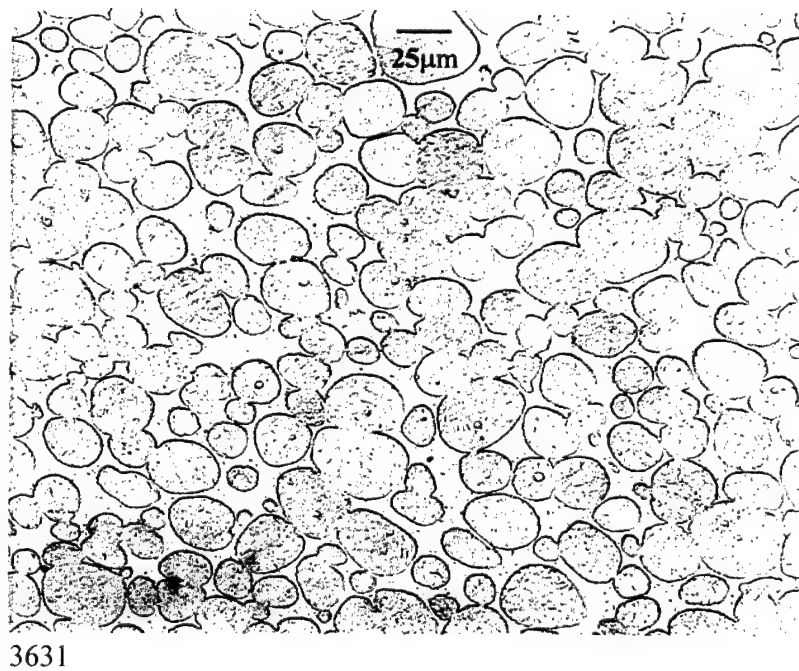
The W particles were somewhat elongated on the tensile side of the samples relative to the compressive side, central fracture region, and regions away from the fracture. The difference in aspect ratio of the W particles is evident upon comparison of Figures 2 and 3. Strains up to 150 % were calculated for the dynamic bend samples based on the extent of elongation of the tungsten particles on the tensile vs. compressive sides of the samples. Particle fracture likely initiated in the most highly strained particles.

Figure 3. Microstructure on the compressive side of the dynamic bend test samples.

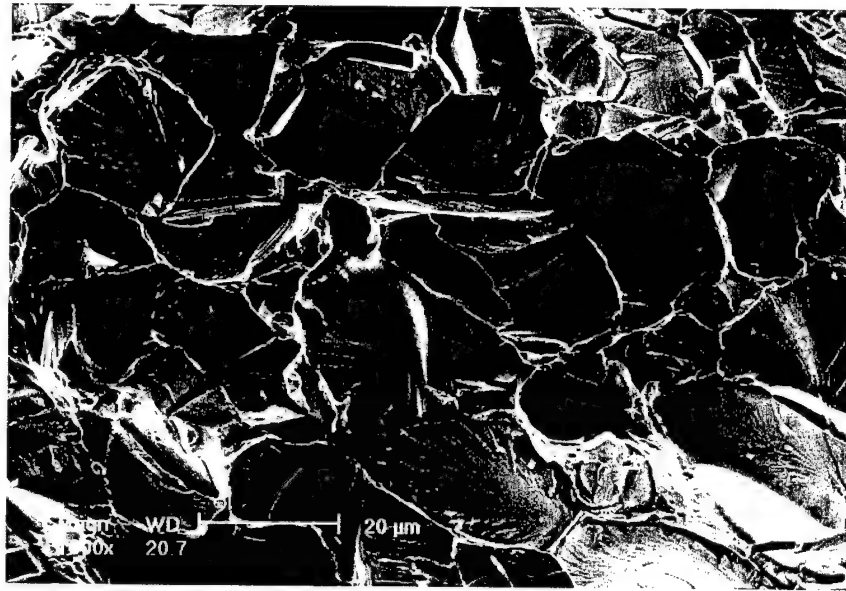
(a) Tensile region

SEM evaluation of the fracture surface confirmed the optical results. Cleavage fracture of the W particles occurred on the tensile side of the fracture, as shown in Fig. 4a. The fracture mode was more ductile towards the central region of the sample. The central region consists of failed intergranular matrix zones, composed of W facets and ductile dimples in the matrix regions. Some cleaved W particles were also detected, along with decohesion between adjacent W particles, and between the W particles and the matrix. Fig. 4b is representative of the central region of the fracture for Sample B. More matrix dimples and W facets were evident in the bend region on the compressive side of the fracture surface. However, W particle cleavage was still observed in the compressive region of the fracture. Compare the compressive region, shown in Fig. 4c, with the other locations on the fracture. Some precipitates are evident in the dimpled matrix regions (Fig. 4d).

Figure 4. SEM micrographs of the fracture surface of Dynamic Bend Sample B.

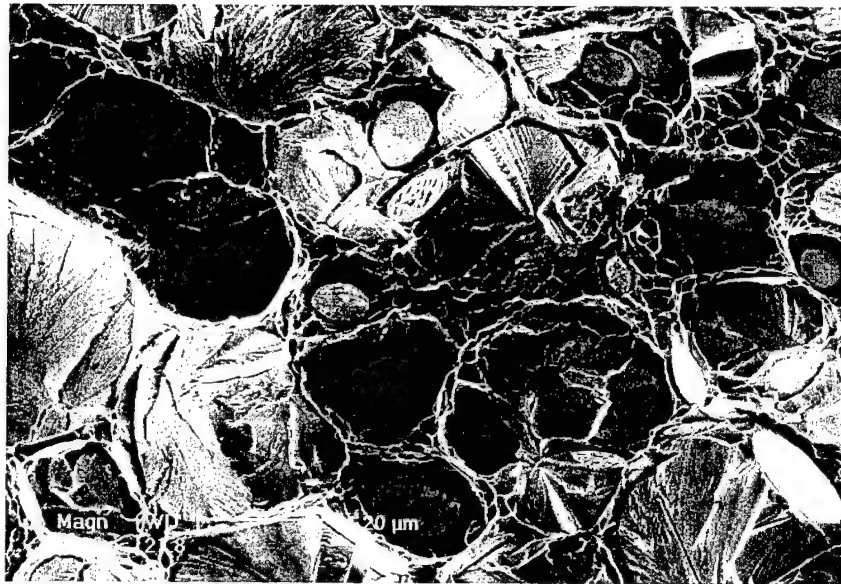
(c) Compressive region

Figure 4. SEM micrographs of the fracture surface of Dynamic

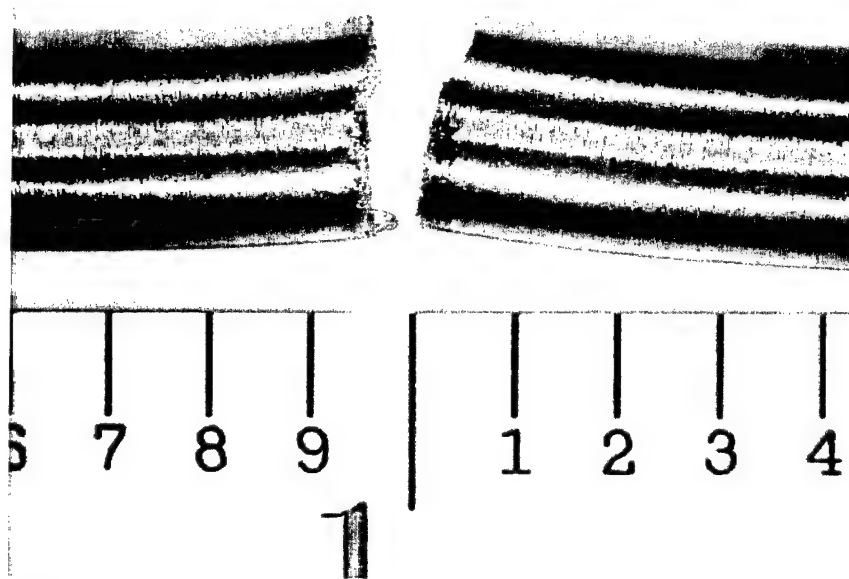
(a) As-received condition

Figure 5. Fracture of the WHA rod (Shot 74) following dynamic transverse impact

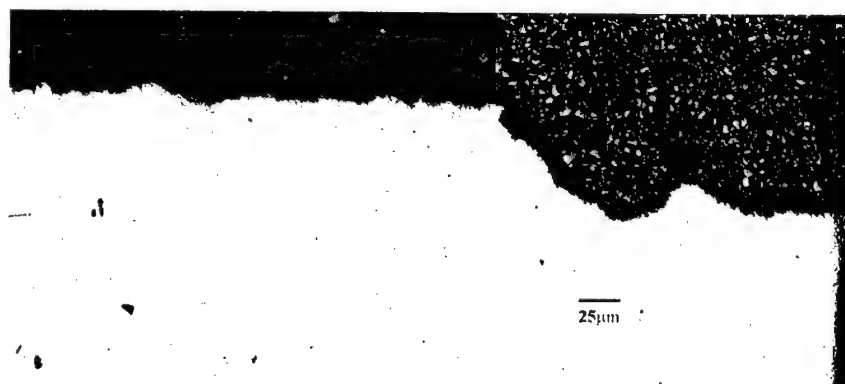
(b) Cross-section through the fracture

Fractographic and metallographic evaluation of the fractured sample revealed the operation of competitive tensile and compressive fracture modes. The micrograph in Fig. 5b illustrates distinct tensile and compressive regions on the fracture surface. The Al impactor imparted a compressive load. Tensile loading occurred on the surface opposite the impact. Comparison of the microstructures in the tensile and compressive regions of the mounted cross section showed that elongation of the W particles was not as significant for this sample relative to the dynamic bend samples. Maximum strain levels approaching 20 to 40 % were calculated based on particle elongations.

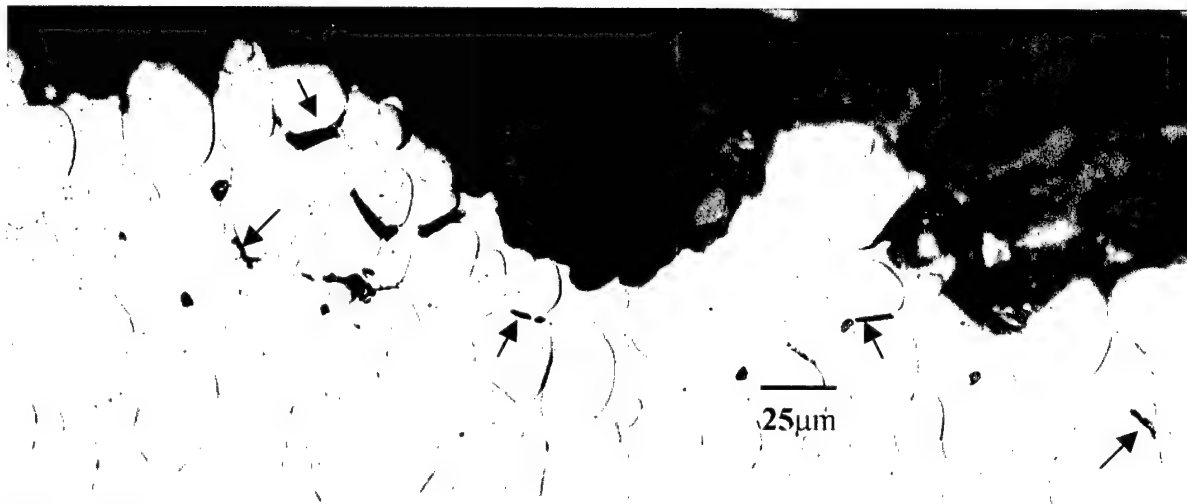
Although a few fractured W particles were observed in the vicinity of the impact region, generally, W particle cleavage was not observed. The W particles remained intact along the fracture surface path as illustrated in Fig. 6. Note the intergranular nature of the fracture path. A limited number of cleaved W particles were evident at the transition region between the tensile and compressive fracture regions. Some W particle fractures were observed on the tensile surface. Although the number of particle fractures observed on the tensile surface was greater for this sample relative to the dynamic bend samples, the fractures only extended through the top two particle surface layers. These had not progressed to form tensile cracks as shown for the dynamic bend test samples in Fig. 2a.

Figure 6. Optical micrograph of a cross section through the fracture surface of Shot 74. Damage development by decohesion between contiguous tungsten particles and between the tungsten particle-matrix interface is highlighted by the arrows.

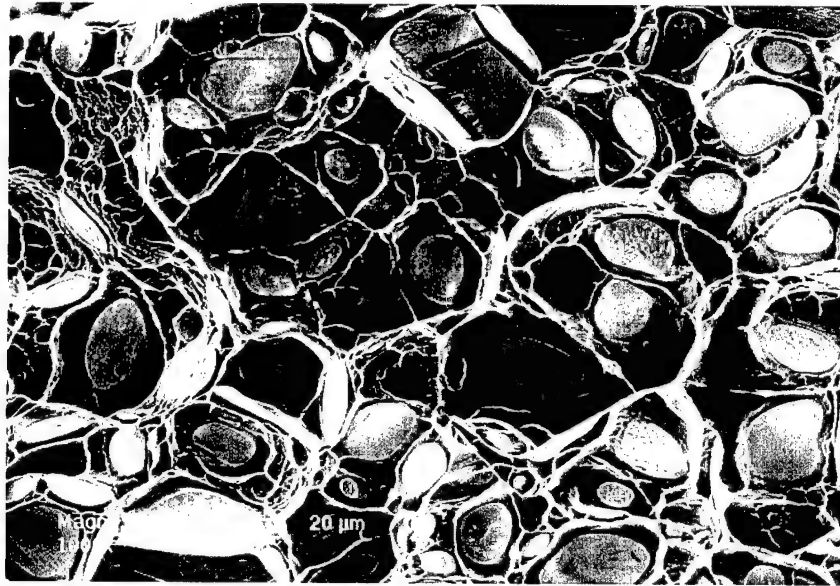
(a) Tensile region

The fractographic features detected in SEM evaluations of Shot 74 support the optical microscopy results. The features are similar to those reported previously by Lankford, et al. [3-5] for WHA materials following dynamic fracture at strain rates up to 1000 s^{-1} . Intergranular fracture is apparent in the SEM micrographs in Fig. 7. The photos show representative areas from the tensile, compressive and central regions of the fracture and confirm that dynamic fracture occurred along tungsten particle and tungsten-matrix interfaces. Macroscopic dimples surrounding individual W grain facets were evident in each of the three regions. Some W particle cleavage was evident for the compressive region (Fig. 7d) near the impact location. Except for some pores surrounding the W facets (see Fig. 7b), there is little evidence of any plastic flow. Dimples in the matrix regions are not as apparent in the W-Ni-Fe dynamic transverse impact sample relative to the W-Ni-Co dynamic bend samples discussed in the previous section. Note the differences in matrix plastic flow upon comparison of Figs. 4 and 7 for the dynamic bend and dynamic transverse fracture test samples. This difference can be attributed to material differences and strain rate differences.

Figure 7. SEM micrographs of the fracture surface region of Shot 74, following dynamic transverse impact.

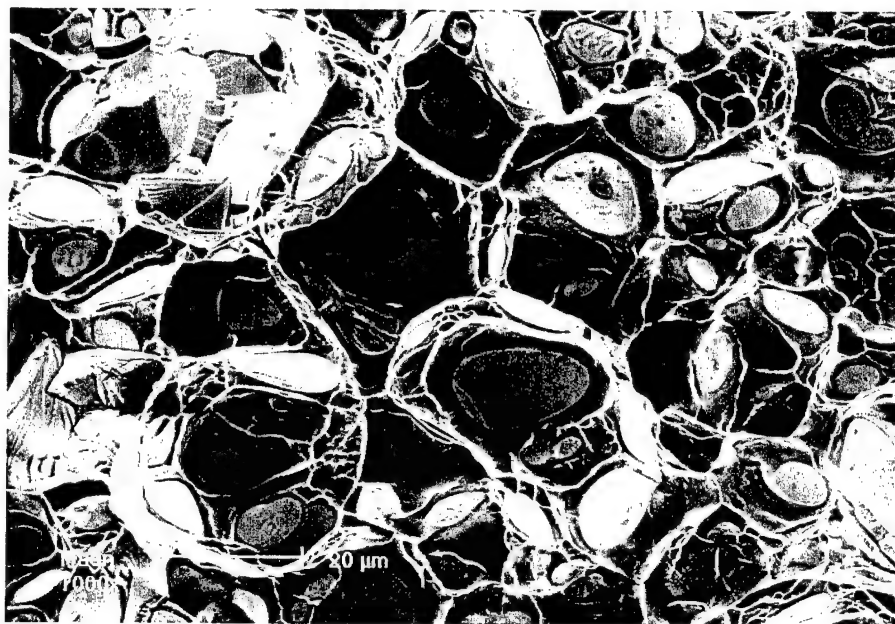
(c) Central region of fracture

Figure 7 SEM micrographs of the fracture surface region of Shot 74, following dynamic transverse impact (continued).

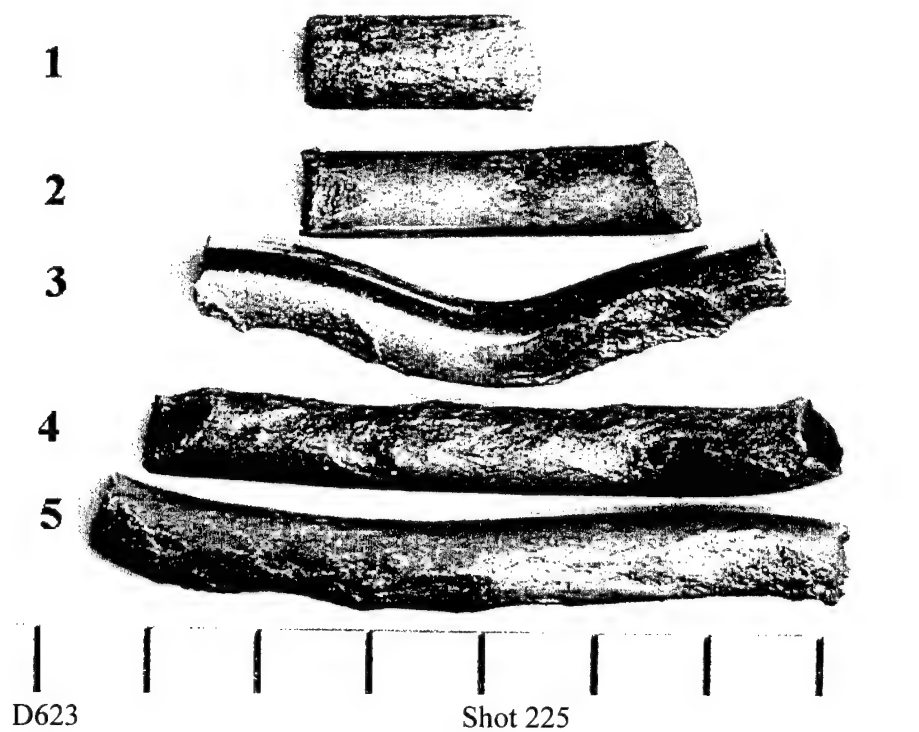
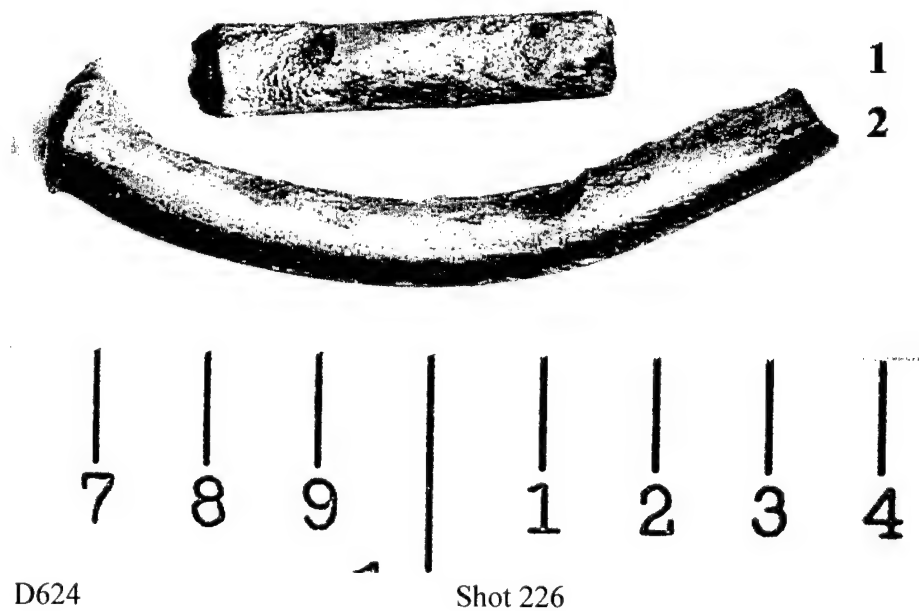
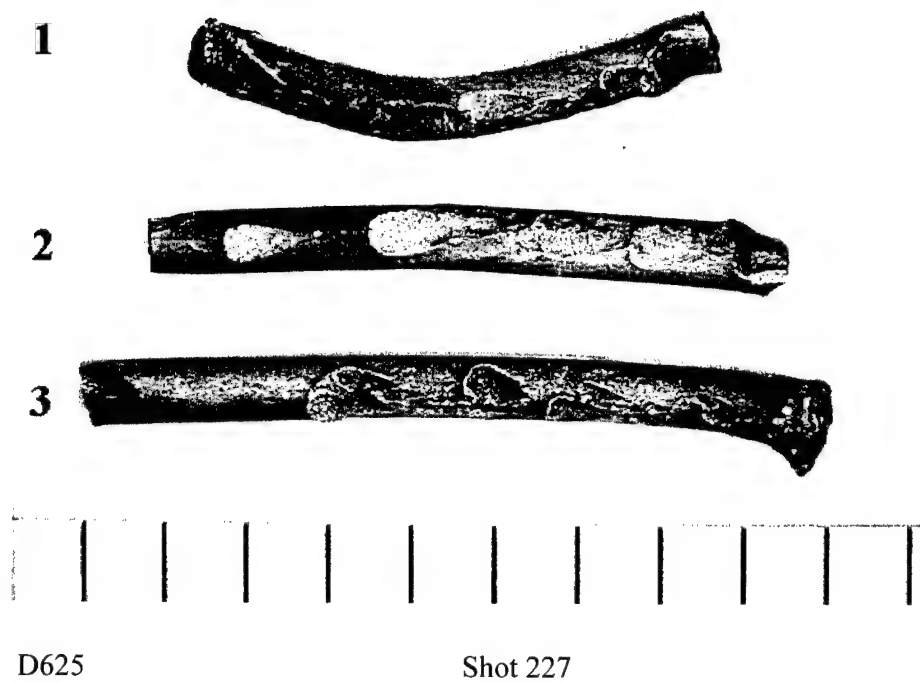
The as-received condition of the remnants from each shot (Shot 225, 226 and 227) is shown in Fig. 8. Impact damage from the target occurred along the surface where the yawed target impacted the W rod. Mushrooming of the impact surface was observed for Shots 226 (Remnant 2, Fig. 8b) and 227 (Remnant 3, Fig. 8c). The extent of mushrooming and surface impact damage is shown in the enlarged view of Shot 227, Fig. 9. The mushrooming phenomenon is characteristic of penetration and is further described for WHA in Ref. [6]. Shear localization occurs after the development of the mushroomed head (i.e., shear localization occurs at a high strain).

Figure 8. Overall view of fragments supplied from each of the reverse ballistic tests (Shot 225, 226 and 227).

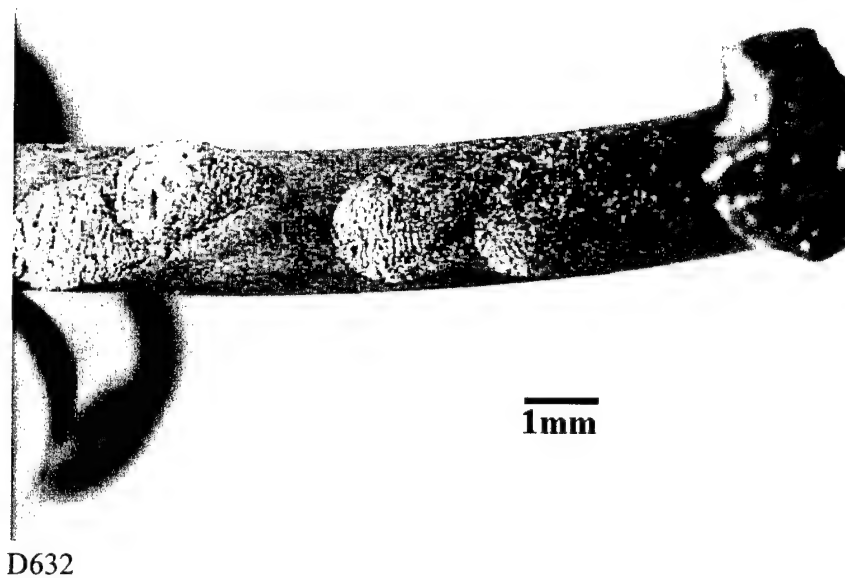
Figure 9. Mushroomed fracture surface and impacted regions for Shot 226.

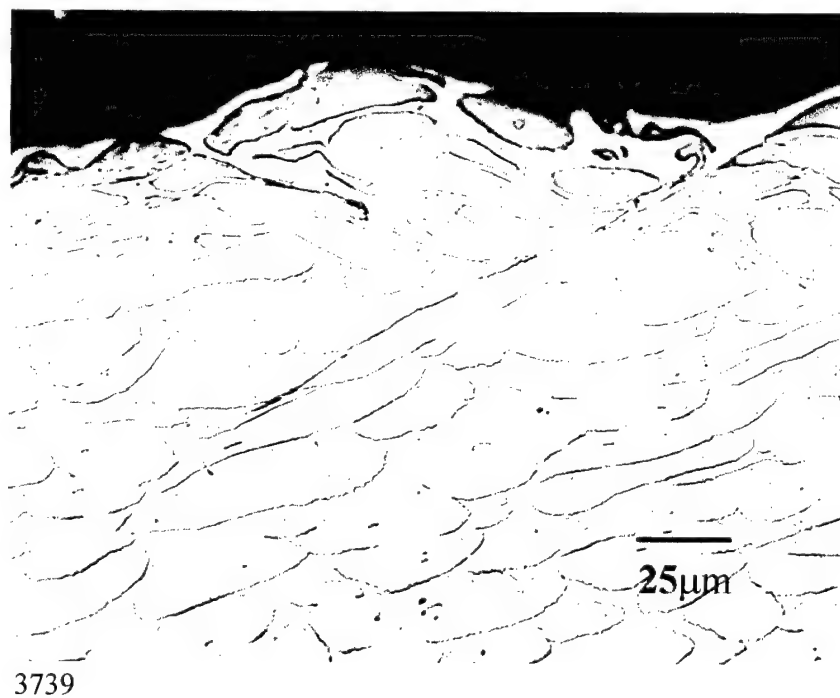
mushroomed ends. The W grains in the mushroomed region were transformed from spherical grains to "pancake"-like grains with extremely high aspect ratios. Elongation of W particles also occurred in the shear band regions. Figure 10 is representative of the shear banding observed, and is consistent with the shear banding reported by Lankford, et al. [3-5] for similar alloys. The extremely high aspect ratio of the W grains within the shear bands indicates that the local shear strains exceeded several hundred percent. Matrix fracture and/or melted matrix areas were detected in some of the shear bands investigated and are further evidence of shear instability.

Figure 10. Elongated particles and matrix fracture in a shear band at the impacted surface of Shot 225 following reverse ballistic testing.

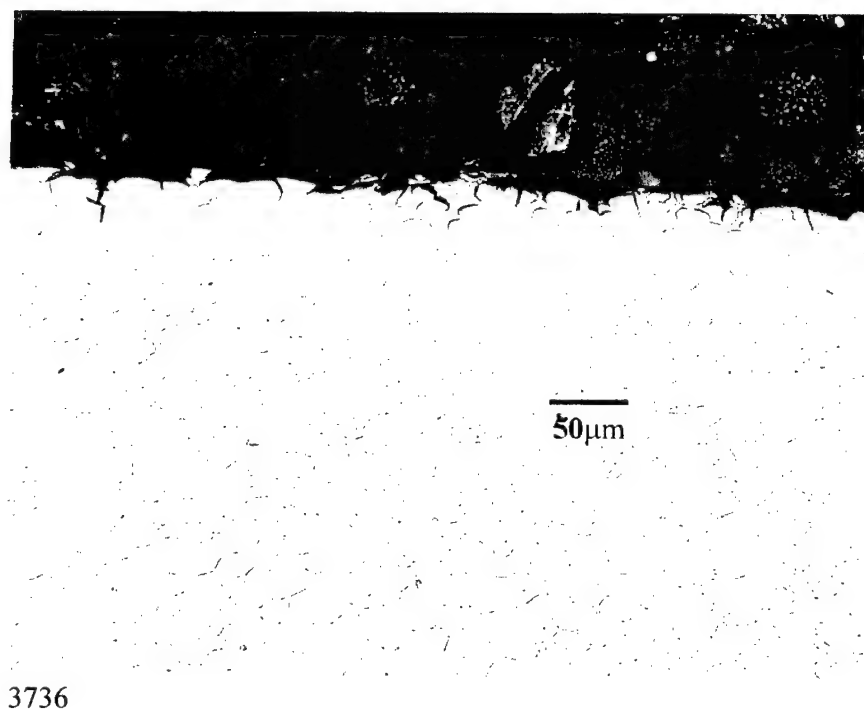
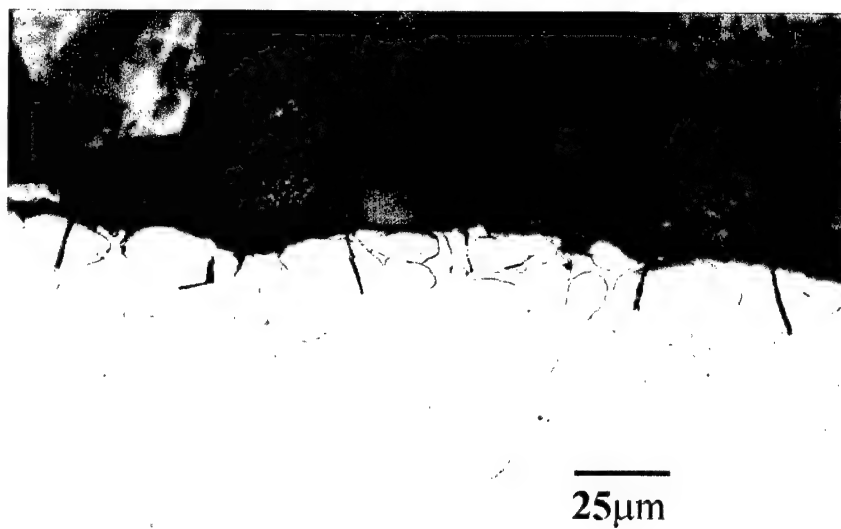
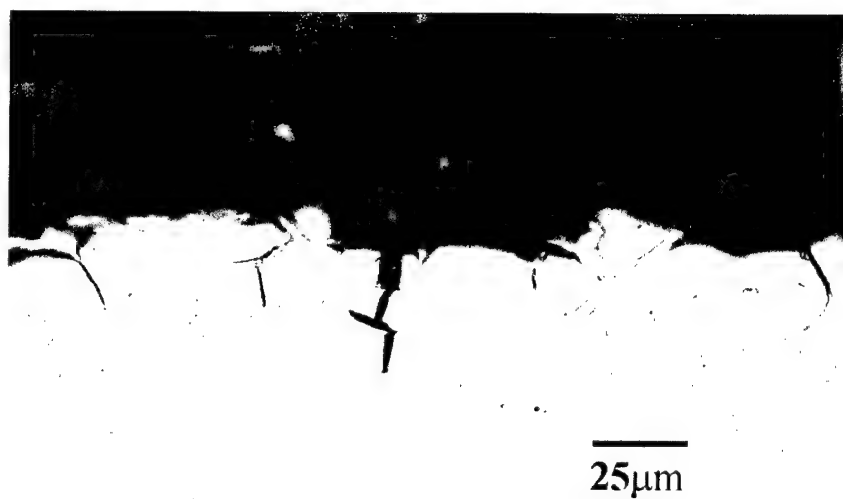
Although shear localization was the predominant form of damage, W particle fracture was observed in some cases on the non-impacted surface (opposite the shear-banded surface) of the remnant. Fracture proceeded through the W particles and appeared to be associated with decohesion of contiguous W particles. Fracture progression through more than three adjacent particles was not detected. The fractured W particles observed at the surface of Shot 227 were concentrated in several regions, and were spaced approximately 30 μm (i.e., a particle spacing) apart. These are illustrated in Fig. 11, taken from the center of the Shot 227 specimen, half-way between two fractured ends (i.e., away from locations where a crack progressed all the way through the rod). These small particle-scale cracks could possibly be examples of widespread initiation sites. However, such fractures are not seen extensively near the fracture surface, and on only one end of the rod are such fractures seen near the actual fracture surface (see Fig. 12). Thus, it is unlikely that many small cracks were uniformly initiated and that the fracture was then dominated by a growth process – i.e., that we should focus on the growth of these small cracks. Rather, understanding initiation is critical.

Figure 11. Low and high magnification views of W particle fractures on the side surface of Shot 227 following reverse ballistic testing. The surface containing the cracks is located opposite the surface containing the shear-banded regions.

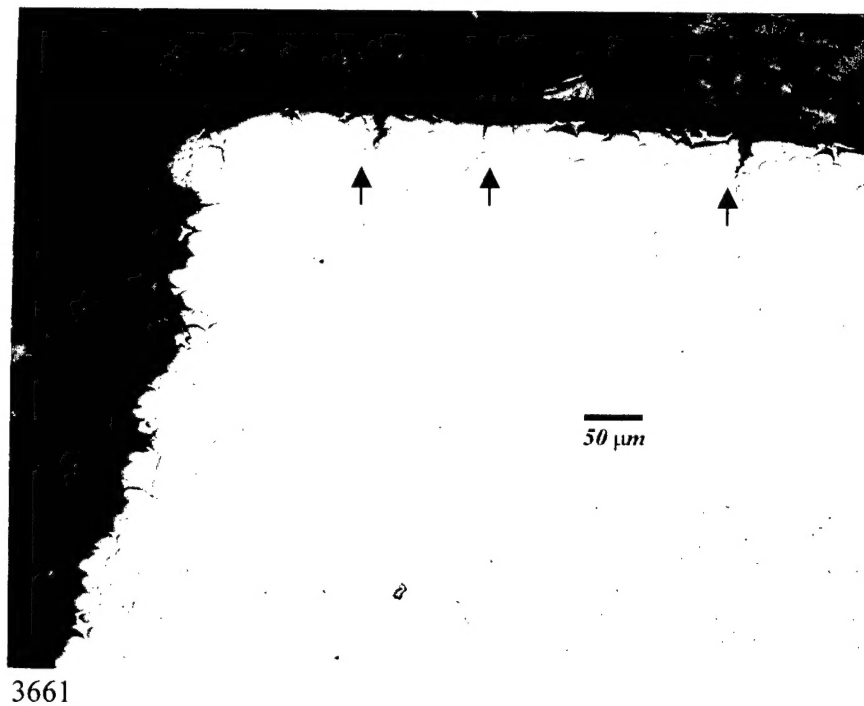
Figure 12. View of one corner of the fracture surface of Shot 227, showing small cracks at the nearby exterior surface.

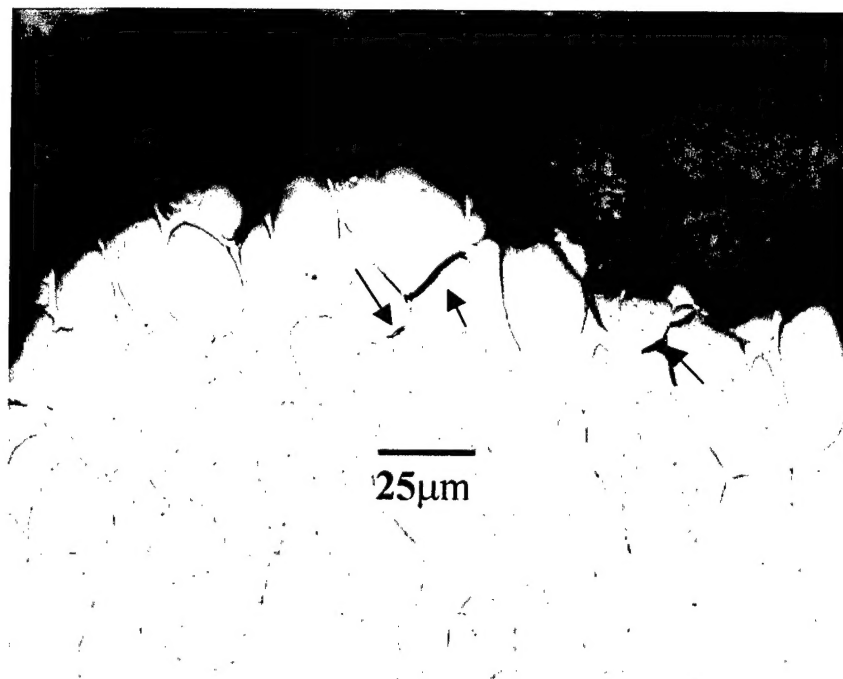
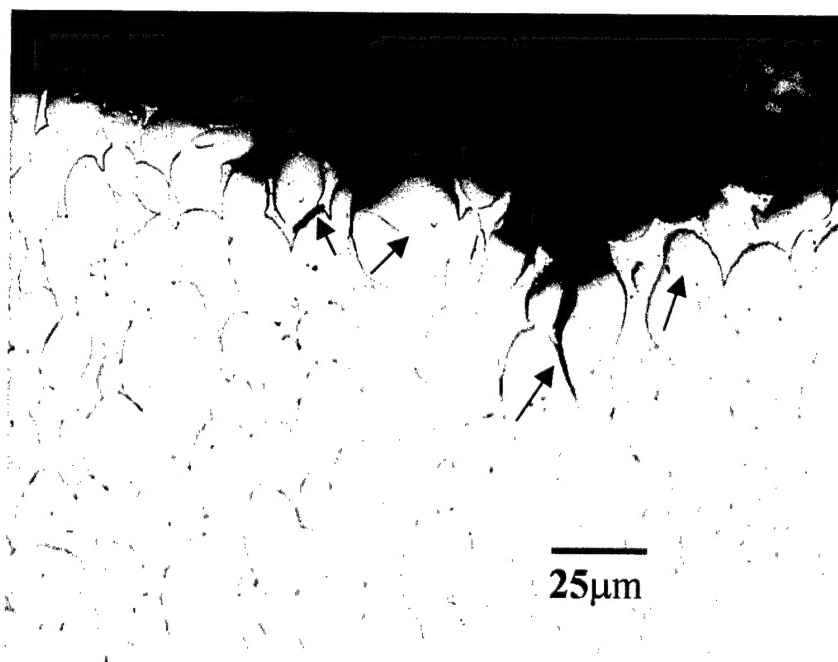
Optical microscopy evaluations of mounted fracture cross-sections revealed decohesion of adjacent W particles and W particle matrix debonds in the vicinity of "non-mushroomed" fracture surfaces. Fractured W-particles appeared to be associated with these debonds. W-particle fracture was also observed along the fracture path and just beneath the fracture surface as shown in Fig. 13 for Shot 227. The fracture surface features for the reverse ballistic samples are similar to those reported above for the dynamic bend test samples.

Figure 13. Enlarged view of the fracture surface of Shot 227 showing particle-particle debonding, particle-matrix debonding and fractured particles.

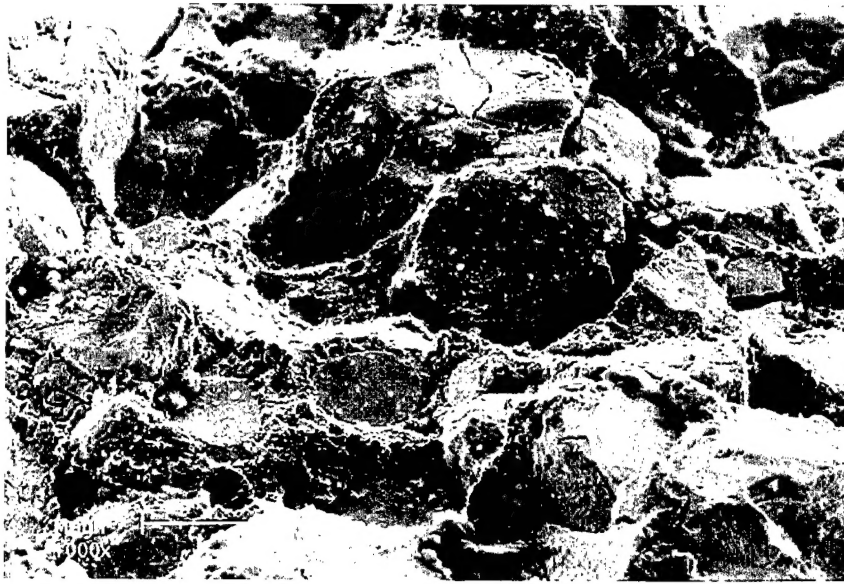
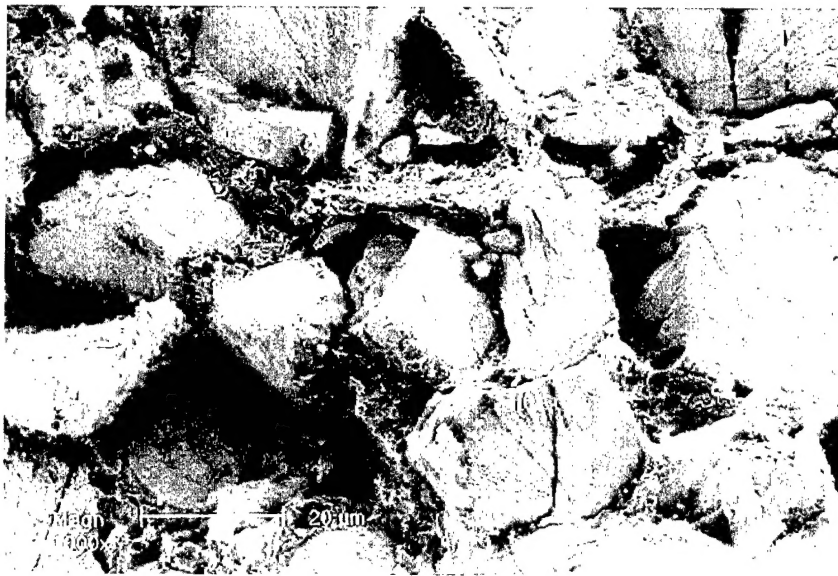
Cleavage of W-particles was more apparent upon SEM evaluation of the "non-mushroomed" fracture surfaces. Evidence of intergranular fracture was observed. Dimpled matrix regions were not as prevalent as for the dynamic bend test samples already discussed (*Dynamic Bend* section) for this alloy. Decohesion of W particles from the matrix was detected in isolated locations. Cleavage of numerous W particles was observed parallel to the rod axis. Representative photos of these features are illustrated in Fig. 14. The fracture mode is more brittle than the other test samples evaluated owing to the high loading rate and yawed projectile.

Figure 14. SEM micrographs of the fracture surface of Shot 227 showing W particle-matrix decohesion, cleaved and faceted W particles.
